11th Generation Intel® Core™ Processor

Specification Update

Rev. 030

July 2025

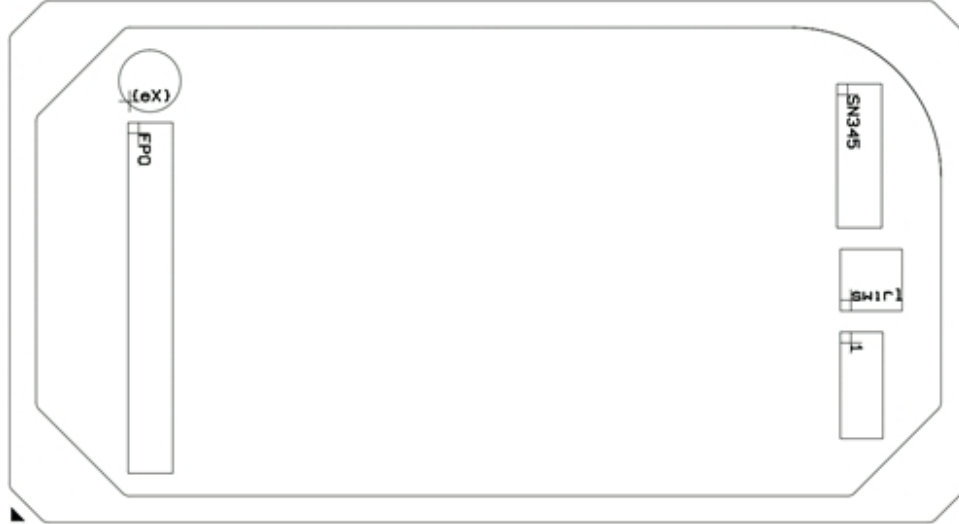
Figure 2-1. Processor Based on UP3/H35/UP3-Refresh/H35-Refresh Processor Line Multi-Chip Package BGA Top-Side Markings

Pin Count: 1449 Package Size: 45.5 mm x 25 mm

- FPO: FPOxxxxx
- {eX}
- SWIR1: Intel® logo

Note: "1" is used to extract the unit visual ID (2D ID).

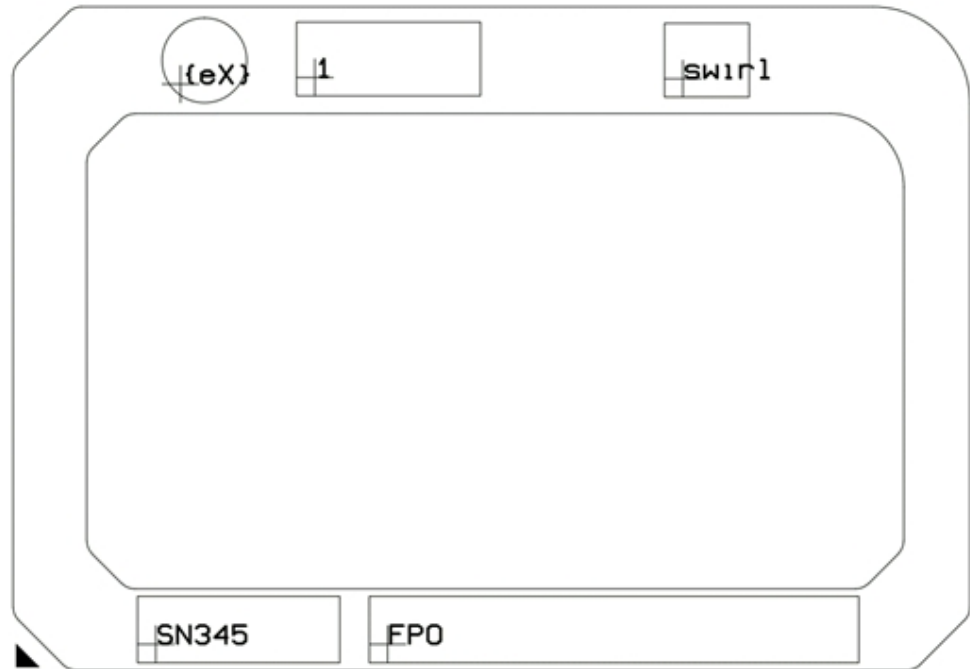
Figure 2-2. Processor Based on UP4 Processor Line Multi-Chip Package BGA Top-Side Markings

Pin Count: 1598 Package Size: 26.5 mm x 18.5 mm

Note: "1" is used to extract the unit visual ID (2D ID).
