12th Generation Intel® Core™ Processor

Specification Update

Rev. 032
August 2025

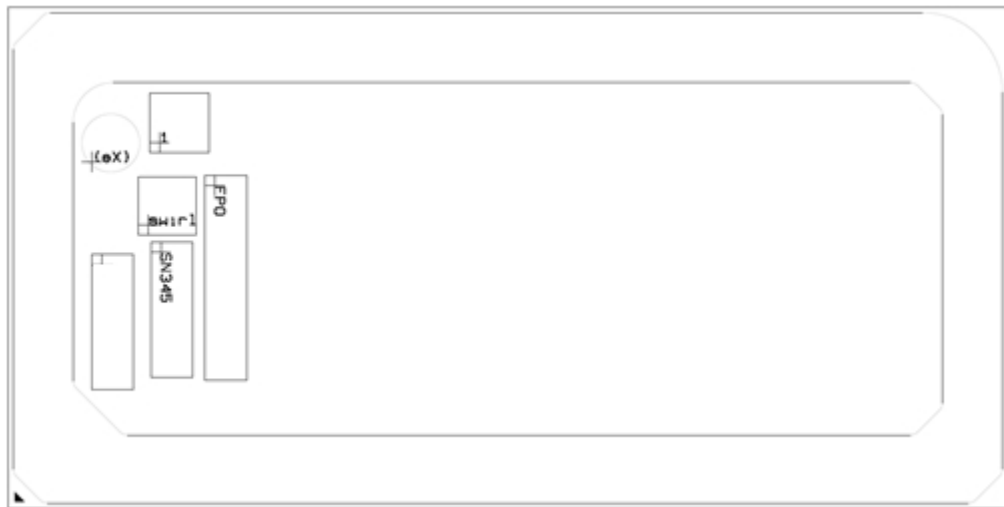
Figure 2-3. Processor Based on U15 Processor Line Chip Package BGA Top-Side Markings

Pin Count: 1744 Package Size: 50mm x 25mm

Note: "1" is unit visual ID (2D ID).
