# 4th Gen Intel® Xeon® Processor Scalable Family

**Specification Update**

*Rev. 016US*

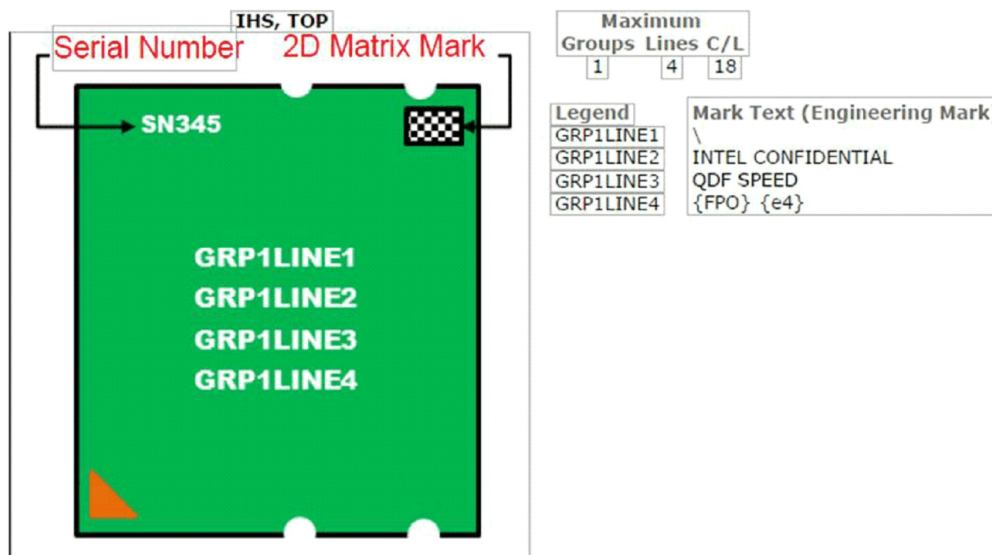
### Processor Preliminary Top Side Marking (Example)

The 4th Gen Intel® Xeon® processor Scalable family can be identified by the following register markings.
