13th Generation Intel® Core™, Intel® Core™ 14th Generation and Intel® Xeon® E 2400 Processor

Specification Update

***Rev. 015
May 2024***

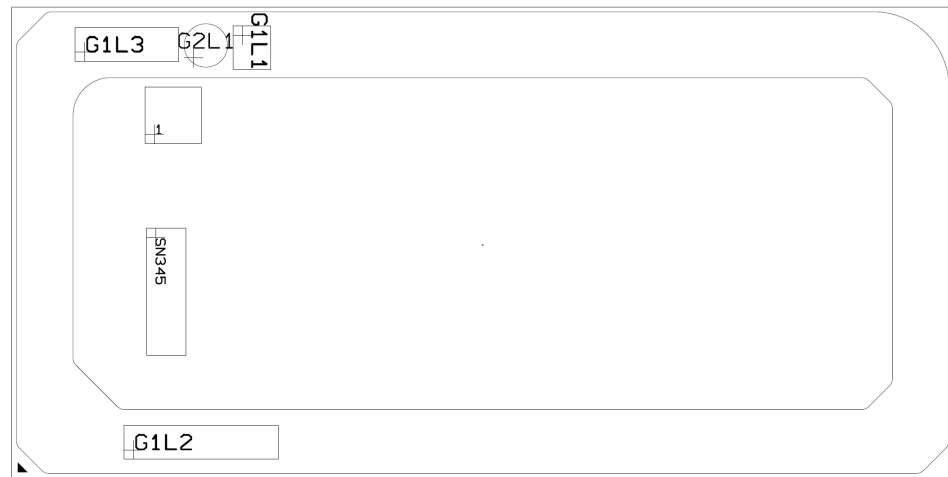
Figure 2-2. Processor Based on H/P-Processor Line Chip Package LGA Top-Side Markings

Pin Count: 1744 Package Size (width x height): 50mm x 25mm
Production (SSPEC):

- SN345
- G1L1: SPARK (Intel logo)
- G1L2: FPO
- G1L3: SSPEC
- G2L1: {ex}

Note: "1" is used to extract the unit visual ID (2D ID).
