11th Generation Intel® Core™ Processor

Specification Update

Rev. 029

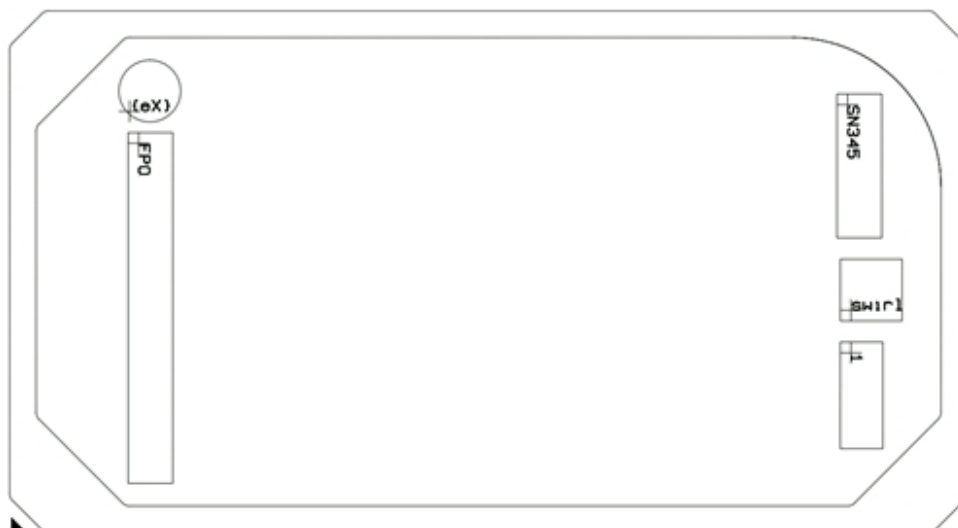
Component Marking Information
Figure 2-1. Processor Based on UP3/H35/UP3-Refresh/H35-Refresh Processor Line Multi-Chip Package BGA Top-Side Markings

Pin Count: 1449 Package Size: 45.5 mm x 25 mm

- FPO: FPOxxxxx
- {eX}
- SWIR1: Intel® logo

Note: "1" is used to extract the unit visual ID (2D ID).

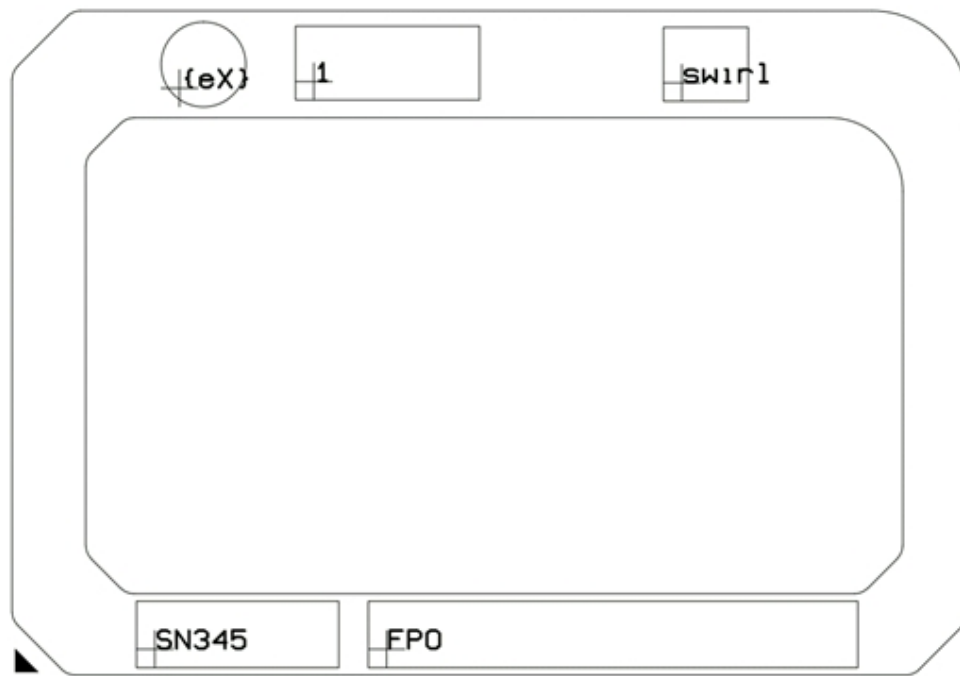
Figure 2-2. Processor Based on UP4 Processor Line Multi-Chip Package BGA Top-Side Markings

Pin Count: 1598 Package Size: 26.5 mm x 18.5 m

Note: “1” is used to extract the unit visual ID (2D ID).
