13th Generation Intel® Core™, Intel® Core™ 14th Generation and Intel® Xeon® E 2400 Processor

Specification Update

Rev. 016
October 2024

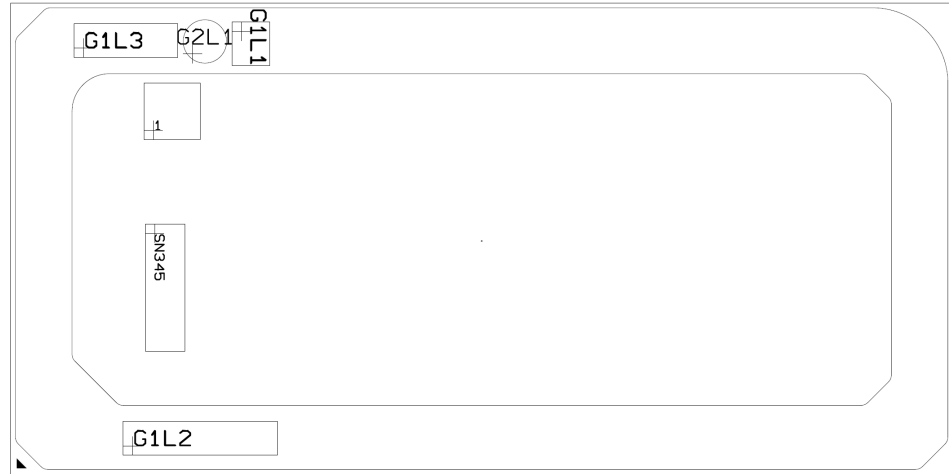
Figure 2-2. Processor Based on H/P-Processor Line Chip Package LGA Top-Side Markings

Pin Count: 1744 Package Size (width x height): 50mm x 25mm

Note: “1” is used to extract the unit visual ID (2D ID).

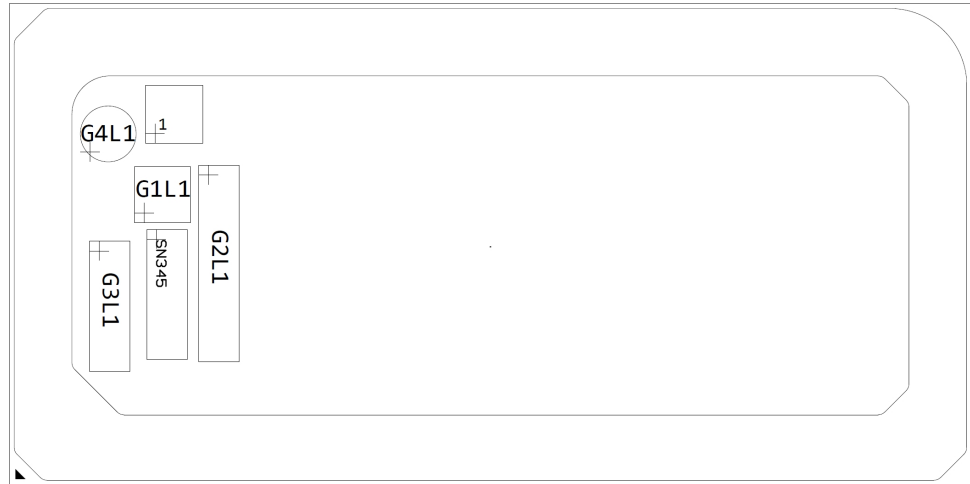
Figure 2-4. Processor Based on U-Processor Line Chip Package LGA Top-Side Markings

Pin Count: 1744 Package Size (width x height): 50mm x 25mm
