12th Generation Intel® Core™ Processor

Specification Update

Rev. 027
October 2024

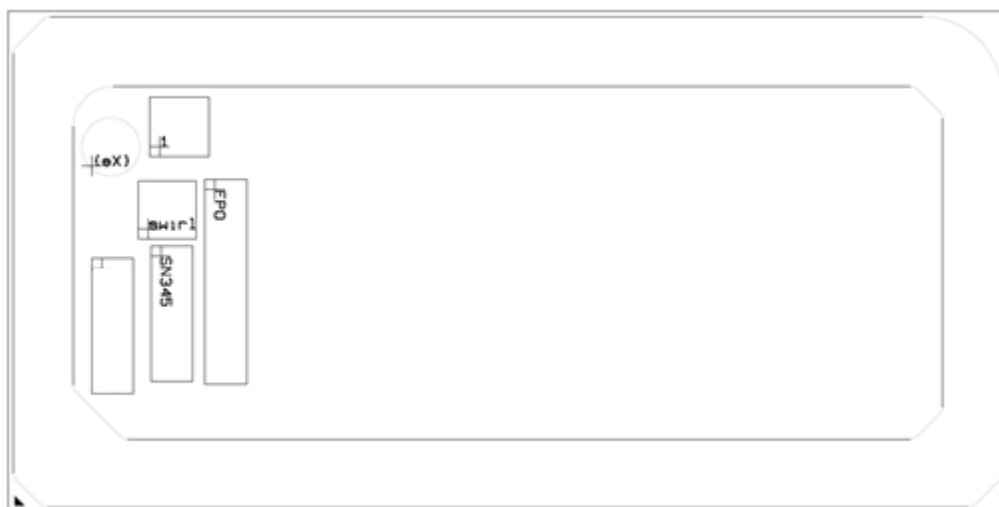
Figure 2-3. Processor Based on U15 Processor Line Chip Package BGA Top-Side Markings

Pin Count: 1744 Package Size: 50mm x 25mm

Note: “1” is unit visual ID (2D ID).
