10th Generation Intel® Core™ Processor

Specification Update

Rev. 021

October 2024

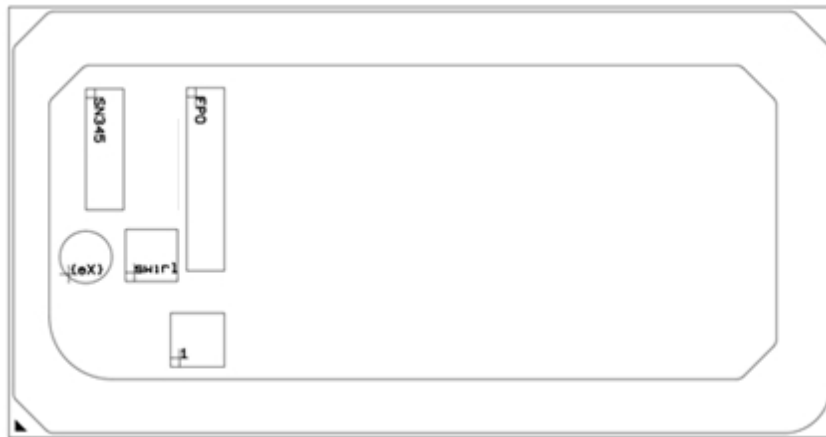
Component Marking Information **Figure 2-1. Based on U-Processor Line Multi-Chip Package BGA Top-Side Markings**

Pin Count: 1526 Package Size: 50 mm x 25 mm

Production (SSPEC):

- FPO: FPOxxxxx
- {eX}
- SWIR1: Intel® logo

Note: "1" is used to extract the unit visual ID (2D ID).
