Intel® Core™ Ultra Processors (Series 2)

Intel® Core™ Ultra Processors (Series 2) Specification Update

Rev. 007
April 2025

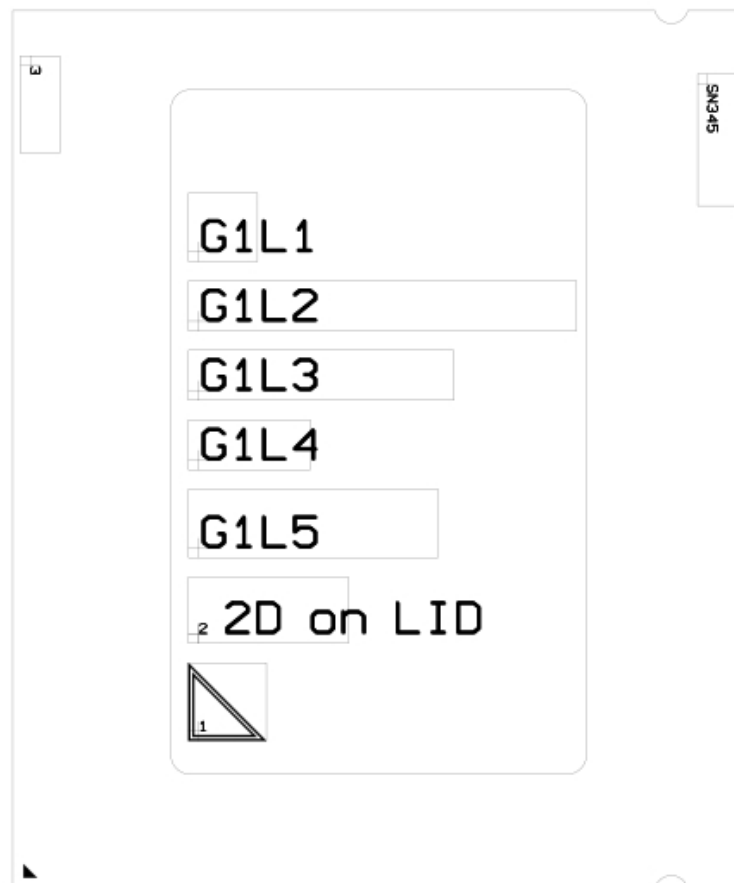
Component Marking Information **Figure 2-1. S-Series Chip Package LGA Top-Side Markings**

Pin Count: 1851 Package Size (width x height): 37.5mm x 45mm

- SN345
- G1L1: SPARK
- G1L2: TRADEMARK
- G1L3: PROC NUMBER
- G1L4: FPO_SSPEC
- G1L5: {ex}

Note: “3” is used to extract the unit visual ID (2D ID).

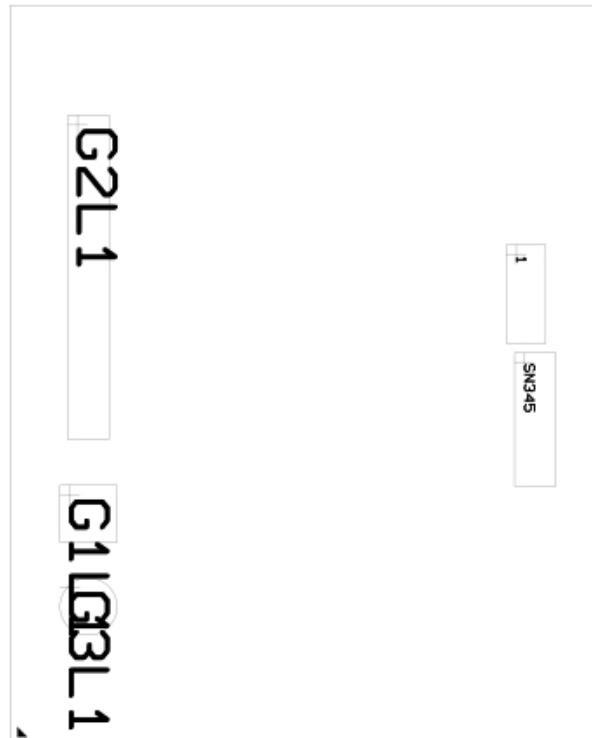
Figure 2-2. HX-Series Chip Package BGA Top-Side Markings

Pin Count: 2114 Package Size (width x height): 30.2 mm x 37.5 mm

- SN345
- G1L1: SPARK
- G2L1: FPO_SSPEC
- G3L1: {ex}

Note: “1” is used to extract the unit visual ID (2D ID).

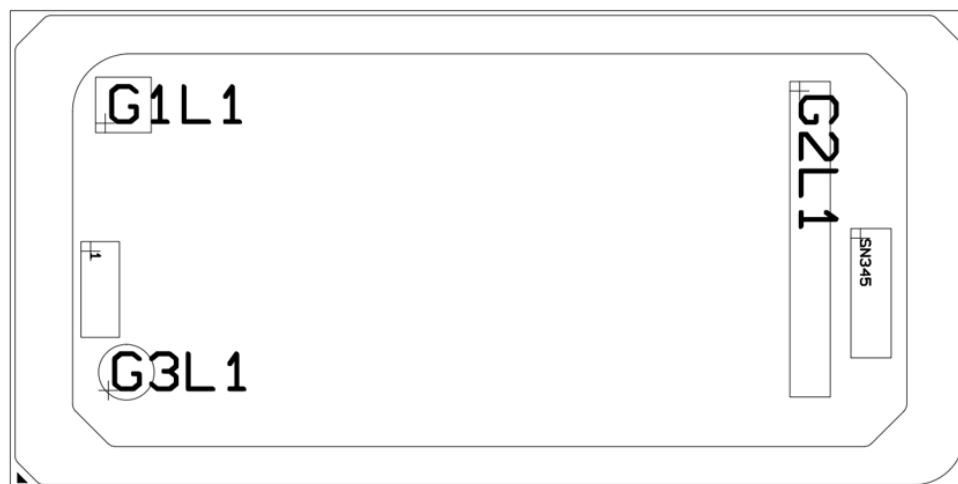
Figure 2-3. H/U-Series Chip Package BGA Top-Side Markings

Pin Count: 2049 Package Size (width x height): 50mm x 25mm
