Intel® Core™ Ultra Processors (Series 2)

Intel® Core™ Ultra Processors (Series 2) Specification Update

Rev. 008
May 2025

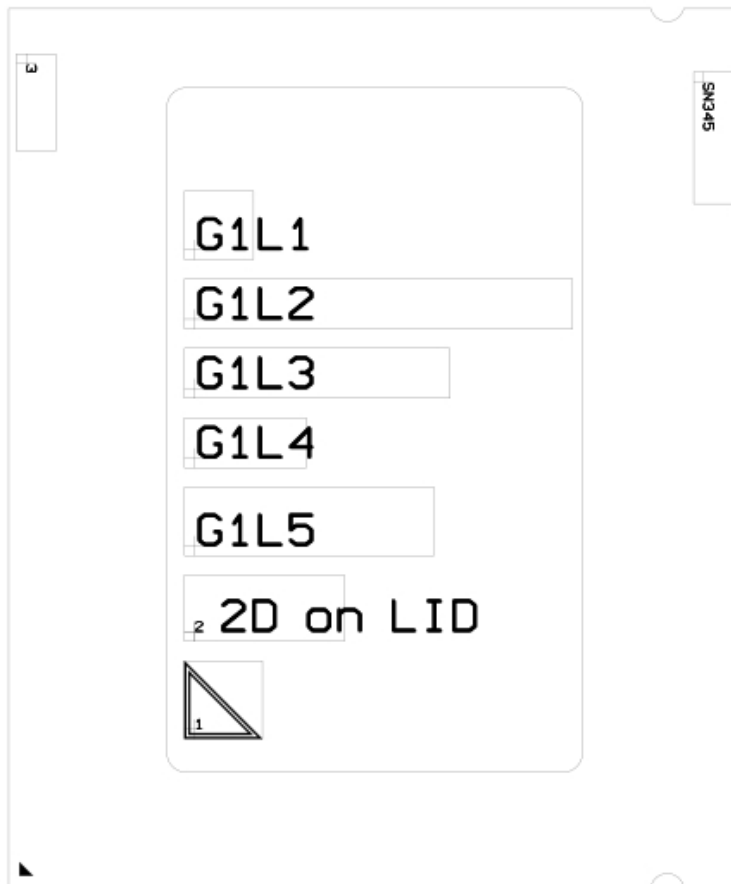
Component Marking Information Figure 2-1. S-Series Chip Package LGA Top-Side Markings

Pin Count: 1851 Package Size (width x height): 37.5mm x 45mm

Note: “3” is used to extract the unit visual ID (2D ID).

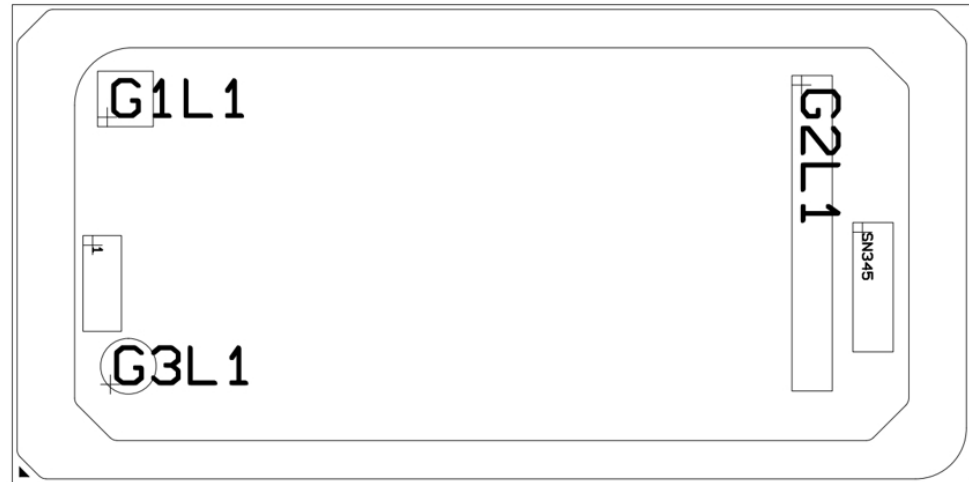
Figure 2-3. H/U-Series Chip Package BGA Top-Side Markings

Pin Count: 2049 Package Size (width x height): 50mm x 25mm
