13th Generation Intel® Core™ Processor

Specification Update

Rev. 003

January 2023

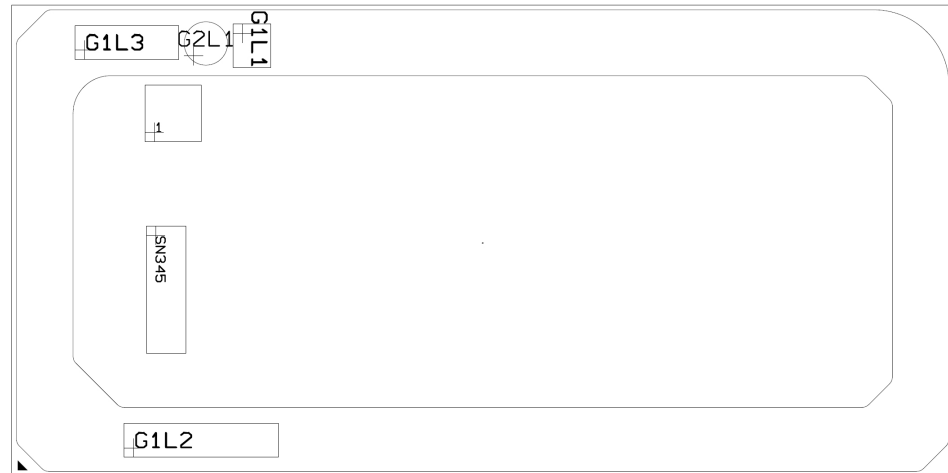
Figure 2. Processor Based on H/P-Processor Line Chip Package LGA Top-Side Markings

Pin Count: 1744 Package Size (width x height): 50mm x 25mm

- SN345
- G1L1: SPARK (Intel logo)
- G1L2: FPO
- G1L3: SSPEC
- G2L1: {ex}

Note: Note: "1" is used to extract the unit visual ID (2D ID).
